Property Inspection Report

Property Address:

2403 Main St
Bigcity, PA 18040

Date of Inspection: March 20, 2010

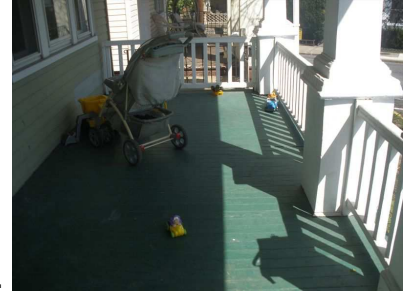
The porch is well-secured to the house. It has a strong base and a solid railing. It seems generally well-protected from water damage although there are a few places where the wood is bare of paint. These should be touched up with paint to protect them from water damage. A few of the deck boards were loose and need to be secured. (for additional detail see photo 5 on Picture Addendum)

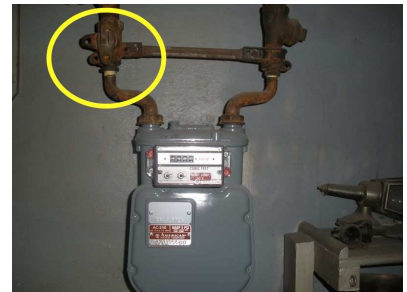
The gas shut off appears to be rusted. This could be a safety hazard and a qualified professional should be consulted. (for additional detail see photo 11 on Picture Addendum)

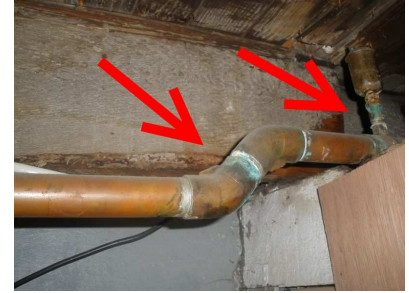
- There are signs of seepage from the pipes.
- There are signs of rust/corrosion on the pipes.

There is some external corrosion of the water pipes but this is not exceptional given the age of the system. A qualified plumber could advise about needed repairs. (for additional detail see photo 15 on Picture Addendum)

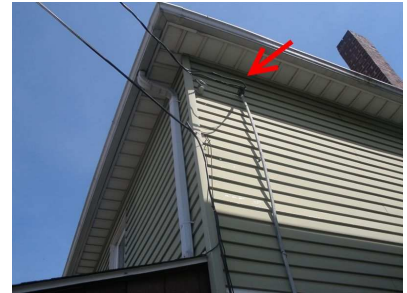
The service entrance wiring is in good condition, the wiring is not frayed or touching the house. There are no trees or obstructions interfering with the lines. (for additional detail see photo 16 on Picture Addendum)

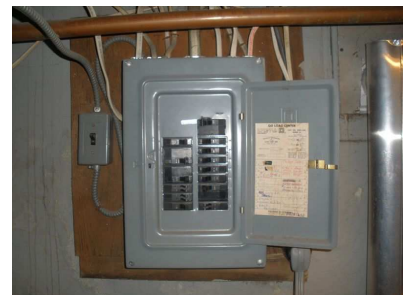
The box is properly labeled and none of the circuits are double tapped. There is no evidence of rust or corrosion affecting the wiring. (for additional detail see photo 17 on Picture Addendum)

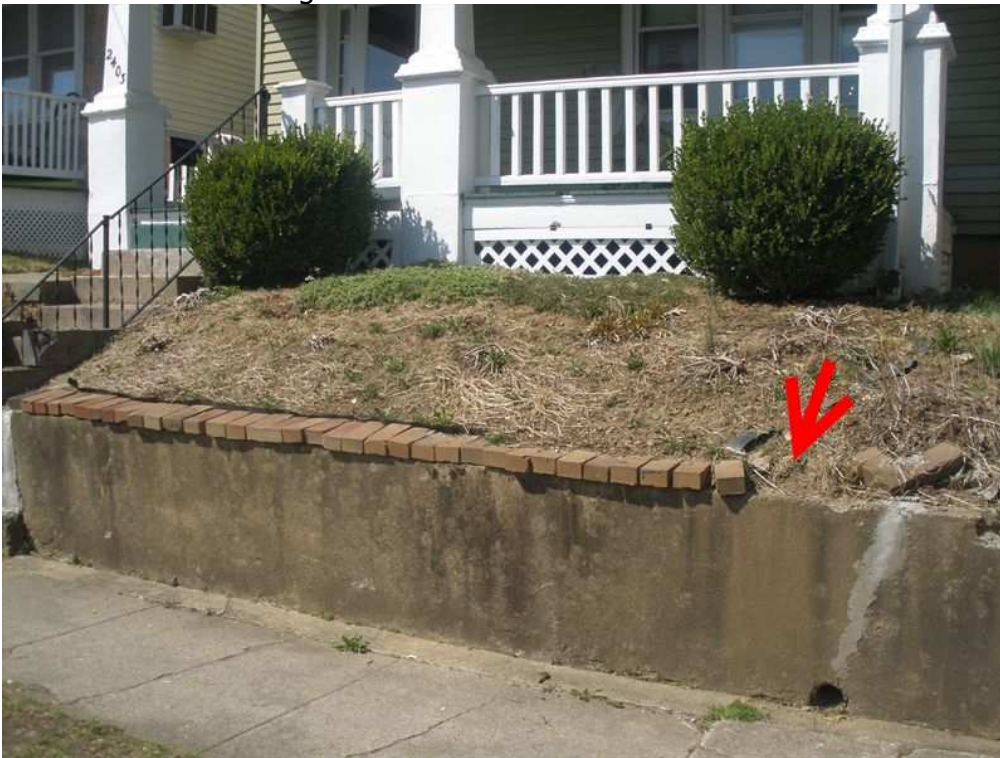
Photo #3 the retaining wall

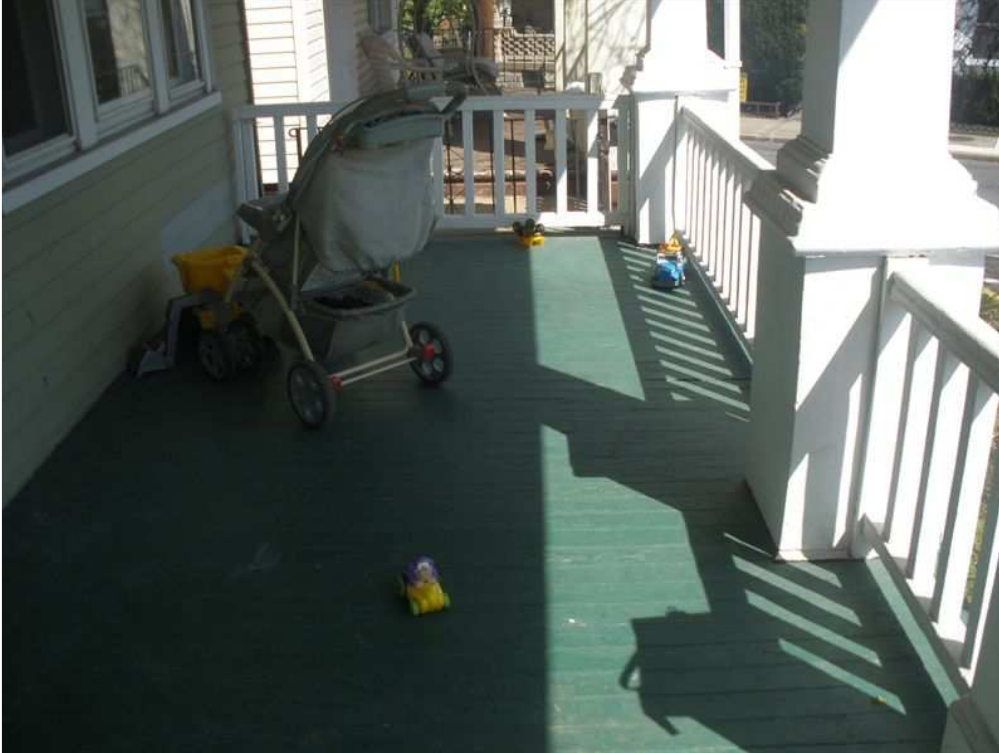
Photo #5 the front porch

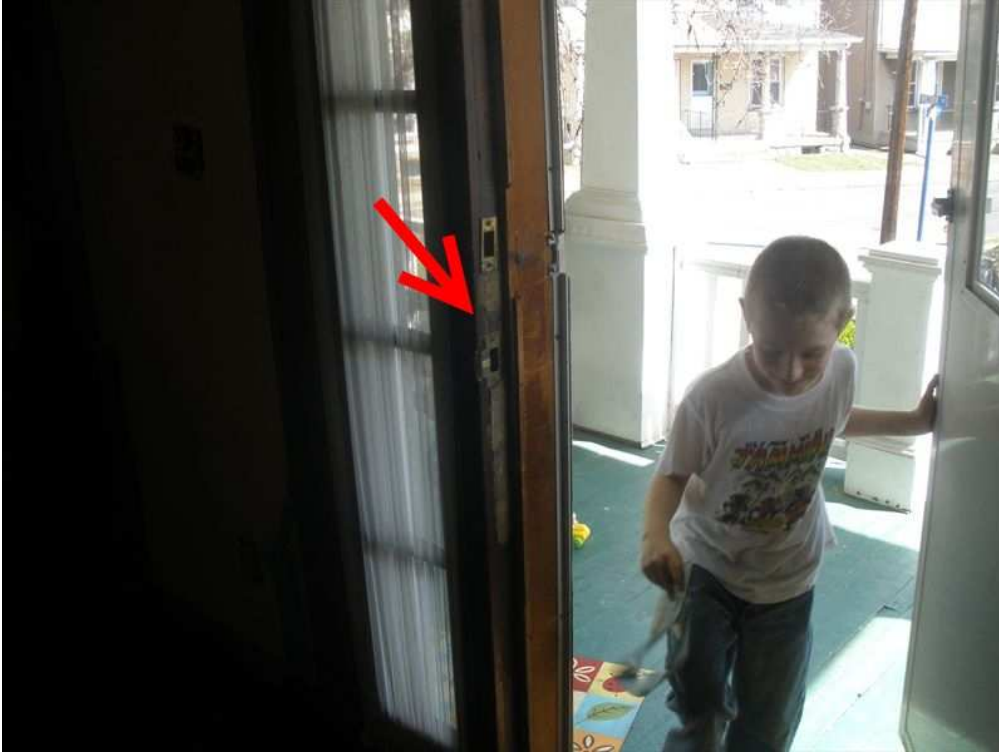
Photo #7 front door

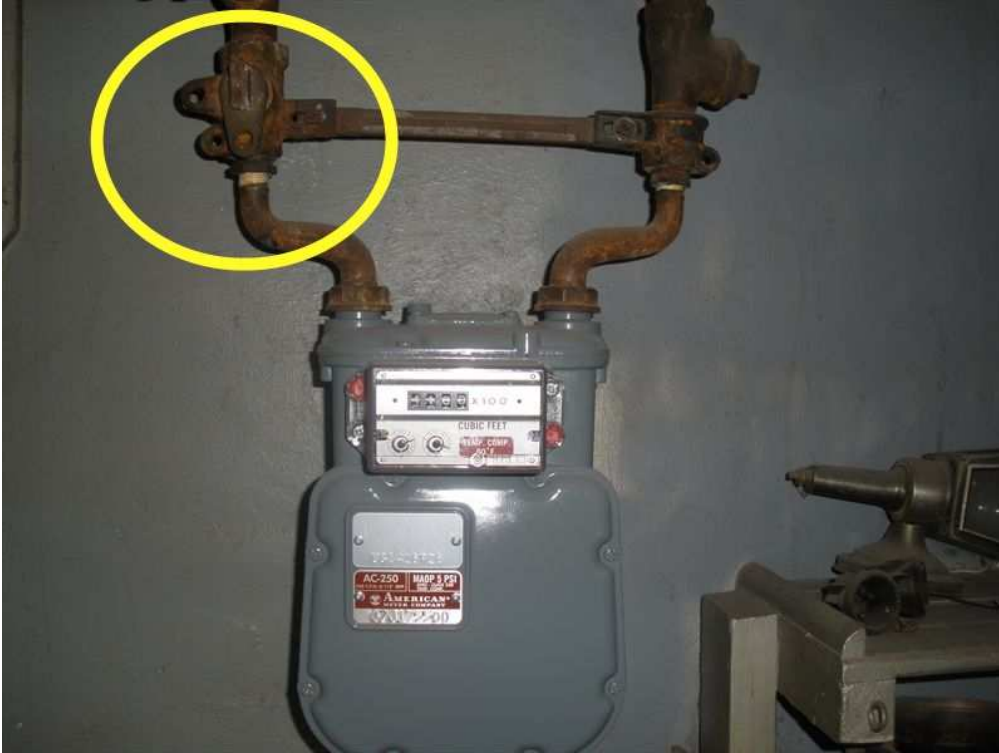
Photo #11 natural gas meter

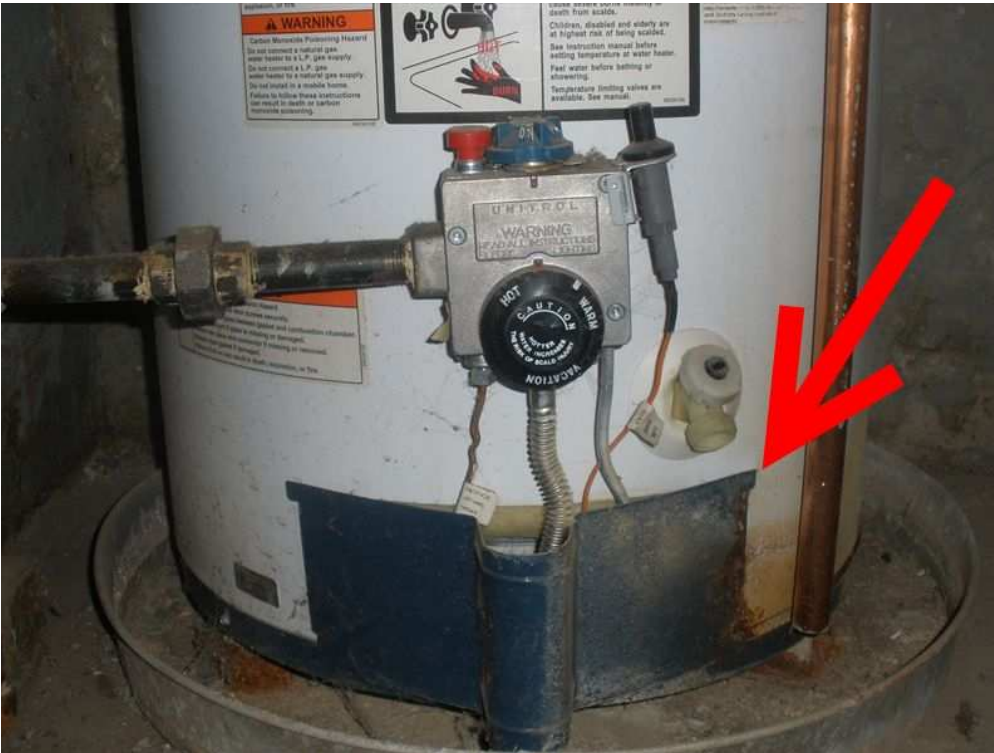
Photo # 14 water heater corrosion

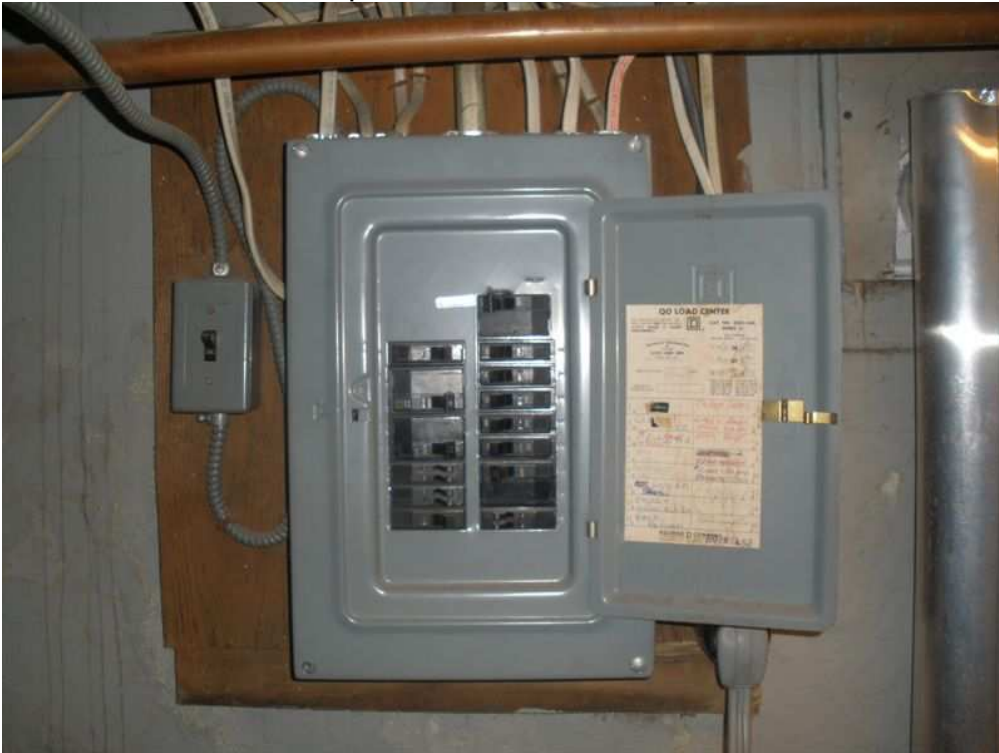
Photo # 17 main service panel

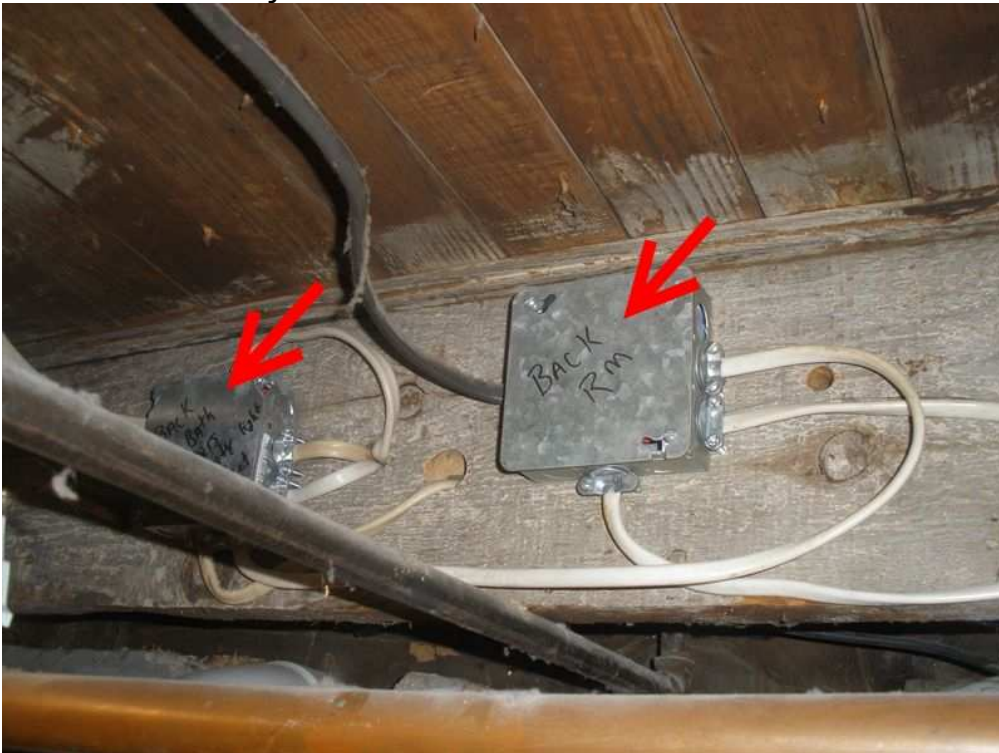
Photo #18 marked junction boxes

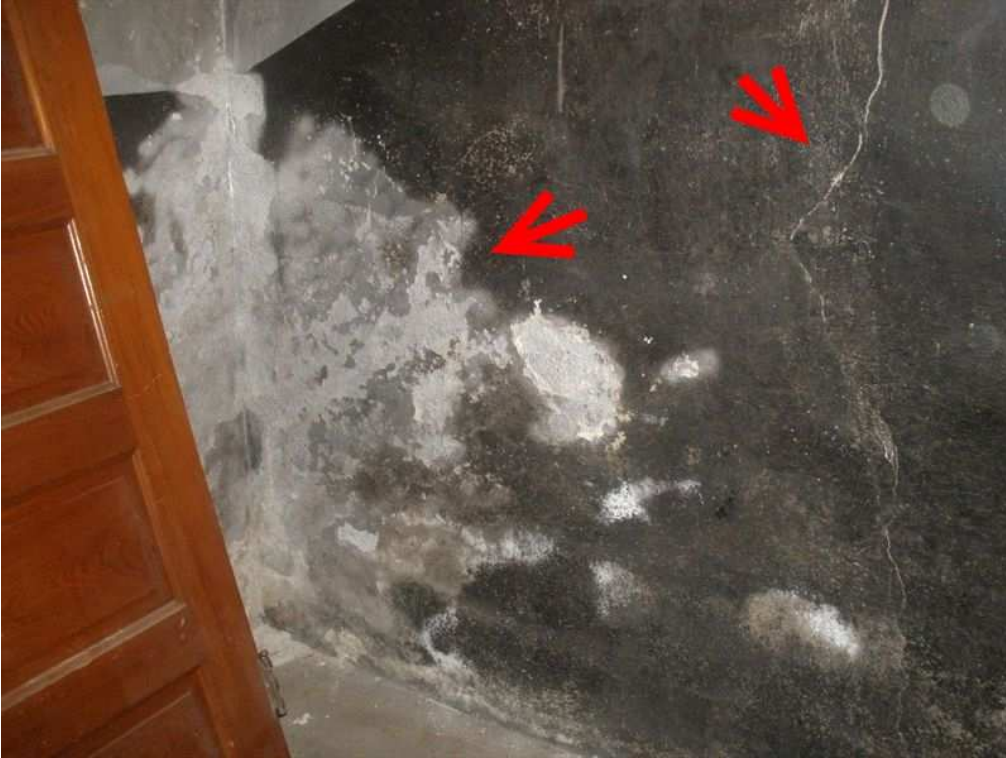
Photo #21 foundation water damage

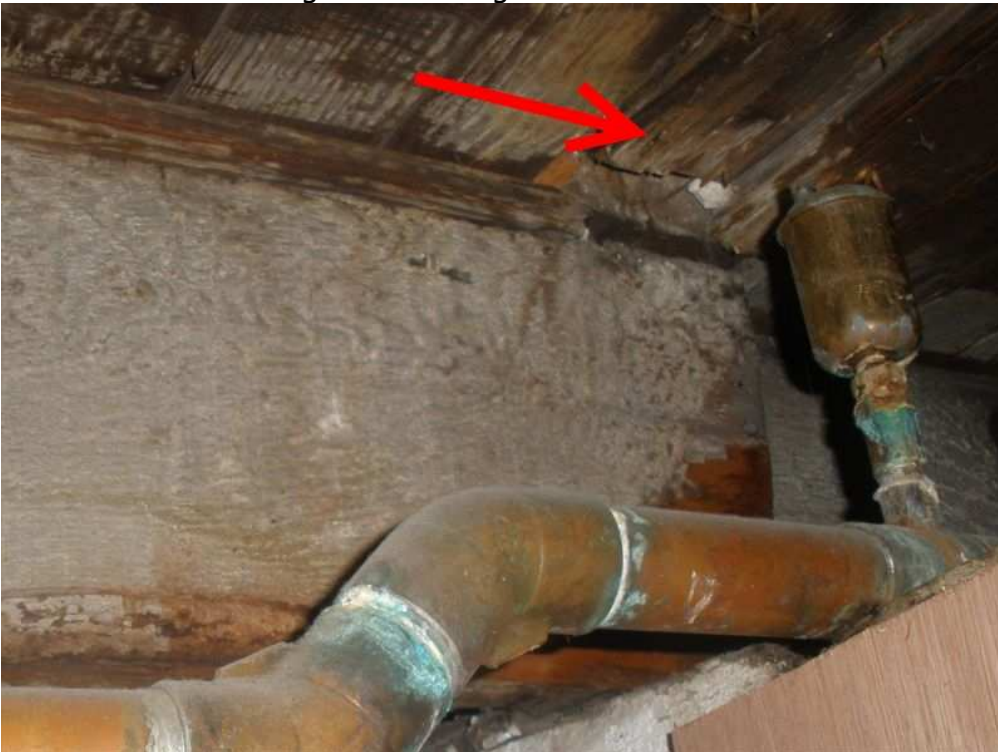
Photo #22 sub flooring water damage
